## **Kaikoura Earthquake Short-Term Project**

**Title: Landslide inventory and landslide dam assessments**

**Kaikoura Earthquake Short-Term Project: Landslide  
inventory and landslide dam assessments**

**GNS Science Report 2018/19**  
**June 2018**

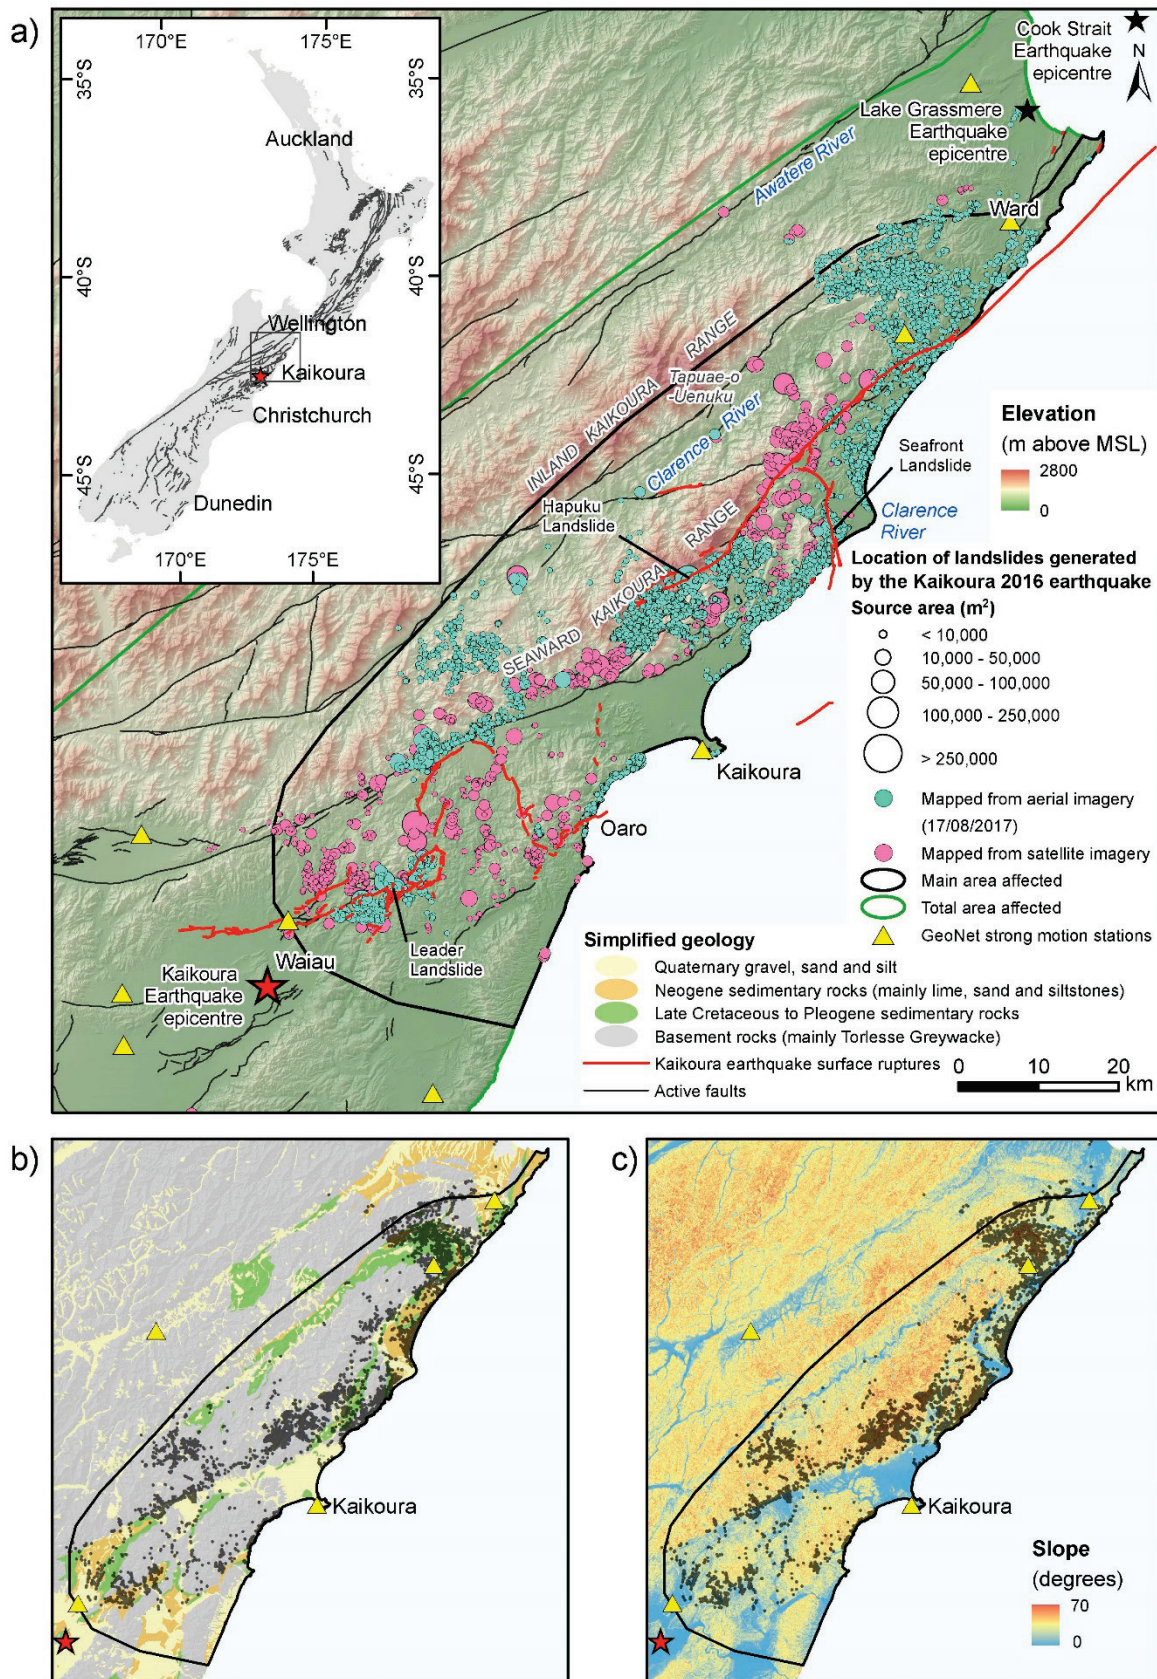
**Figure 2.1** Inset map shows the area of New Zealand affected by earthquake-induced landslides triggered by the Mw 7.8 2016 Kaikoura Earthquake. a) The mapped Version 1.0 of the mapped 10,195 EIL source areas and their size (area) triggered by the earthquake, superimposed on the 8 m ground resolution digital elevation model for New Zealand, classified by elevation in meters above sea level and hill-shaded from the northwest. b) The landslide source area distribution overlain on the main geological units (after Heron, 2014). c) Landslide source area distribution shown on the 8 m ground resolution digital elevation model for New Zealand.

This short-term project allowed the mapping to continue after the response phase, culminating in the release of Version 1.0 of the landslide inventory in August 2017 (Figure 2.1). The Version 1.0 landslide inventory contains 10,195 EIL and is presented in Massey et al. (2018). The version 1.0 inventory contains the results from mapping most of the larger landslides triggered by the earthquake, present in the entire area affected by landslides. It includes some landslides contained in preliminary inventories, mapped from low-resolution satellite images, presented by Rathje et al. (2016). The Version 1.0 inventory is therefore relatively complete for the entire area affected, for those landslides typically > 5,000 m<sup>2</sup>. It is version 1.0, because:

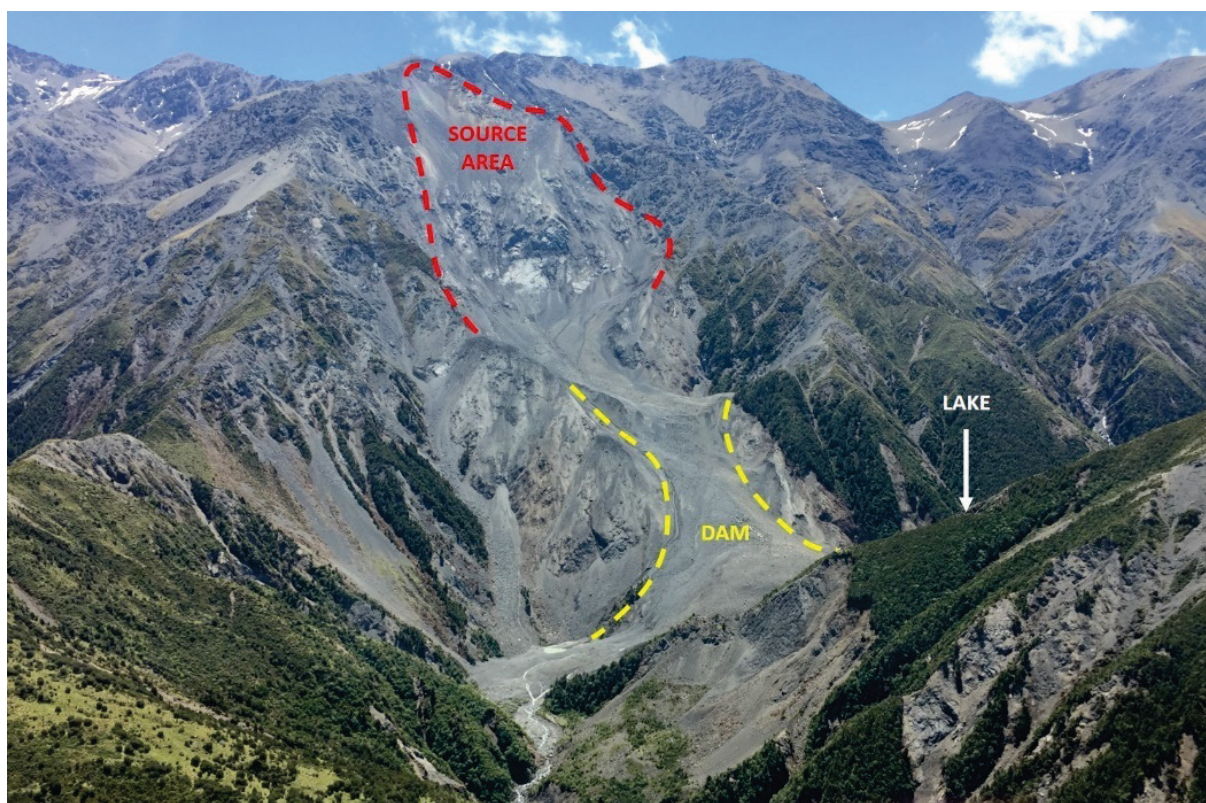
**Figure 2.2** View looking west of the Hapuku rock avalanche and dam. The source area is outlined by a red dashed line. The extent of the debris is outlined by a yellow dashed line. The impounded lake (obscured) and location of the dam are labelled. The dam overtopped on 6 April 2017 and eroded about 2 m off the dam outlet. The dam again overtopped and a substantial breach occurred in October 2017 following rain. Photo taken December 2016.

The Hapuku rock avalanche in Lower Cretaceous basement rocks (greywacke) (Figure 2.2) is the largest of the mapped landslides, with an estimated volume of about  $20 (\pm 2) \text{ M m}^3$ . In this case, the slide surface appears to correspond to multiple persistent discontinuities such as old and recent fault planes. Several faults that ruptured to the surface in the Kaikoura Earthquake (Litchfield et al. 2018; Nicol et al. 2018) pass through the source area of the landslide. The debris left the source and blocked the Hapuku River creating a dam about 100 m high (Figure 2.3). Multiple lobes of debris of different clast size are visible in the deposit, indicating multiple pulses of debris deposition (Figure 2.4). The dam overtopped and the downstream face was partially eroded (due to headward erosion initiated by seepage through the dam) following Cyclone Cook in April 2017. The debris left in the source is still unstable and several debris flows have occurred, which have eroded the debris down to bedrock in places. The debris forming the dam continues to erode as water from the impounded lake flows over the crest and down the outflow channel.

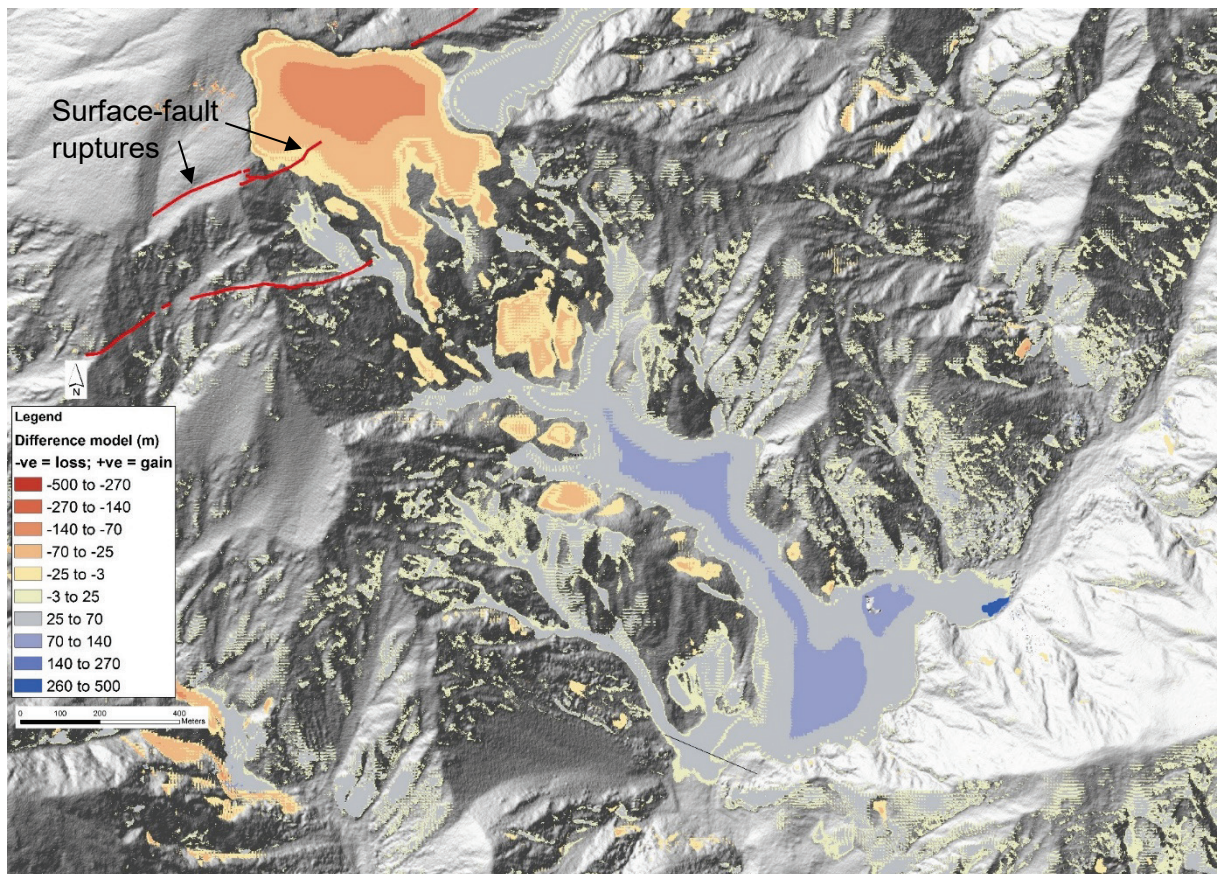
**Figure 2.3** Difference (ground-surface change) model for the Hapuku rock avalanche. The difference model was developed by subtracting the pre-earthquake digital surface model (DSM) developed from the 0.3 m resolution aerial images, from the post-earthquake surface model derived from airborne lidar. The difference model does not show any vertical changes (positive or negative) of less than  $\pm 3$  m, as these smaller changes mostly represent vegetation effects. Reds, oranges and yellows represent loss of material inferred to be erosion. Blues to purples represent a gain of material inferred to be deposition. Red lines represent faults that ruptured to the surface.

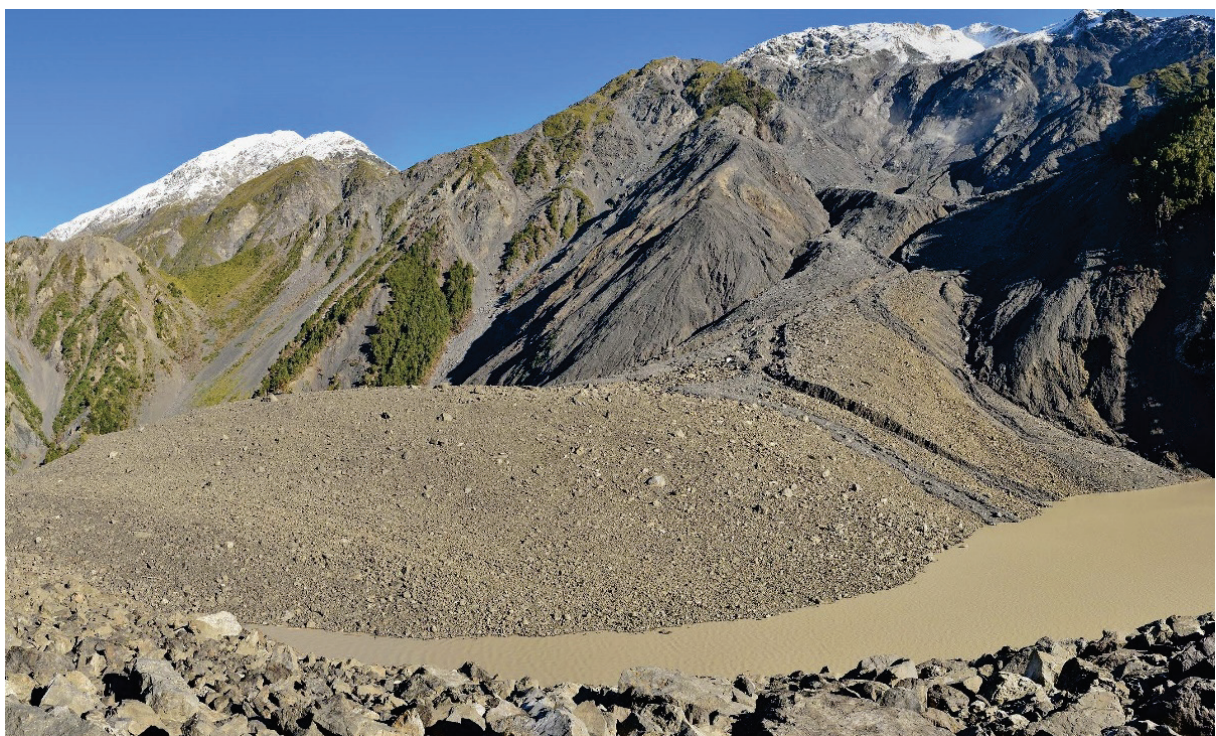
**Figure 2.4** View of the Hapuku rock avalanche from the upstream side of the dam. Photo taken March 2017.

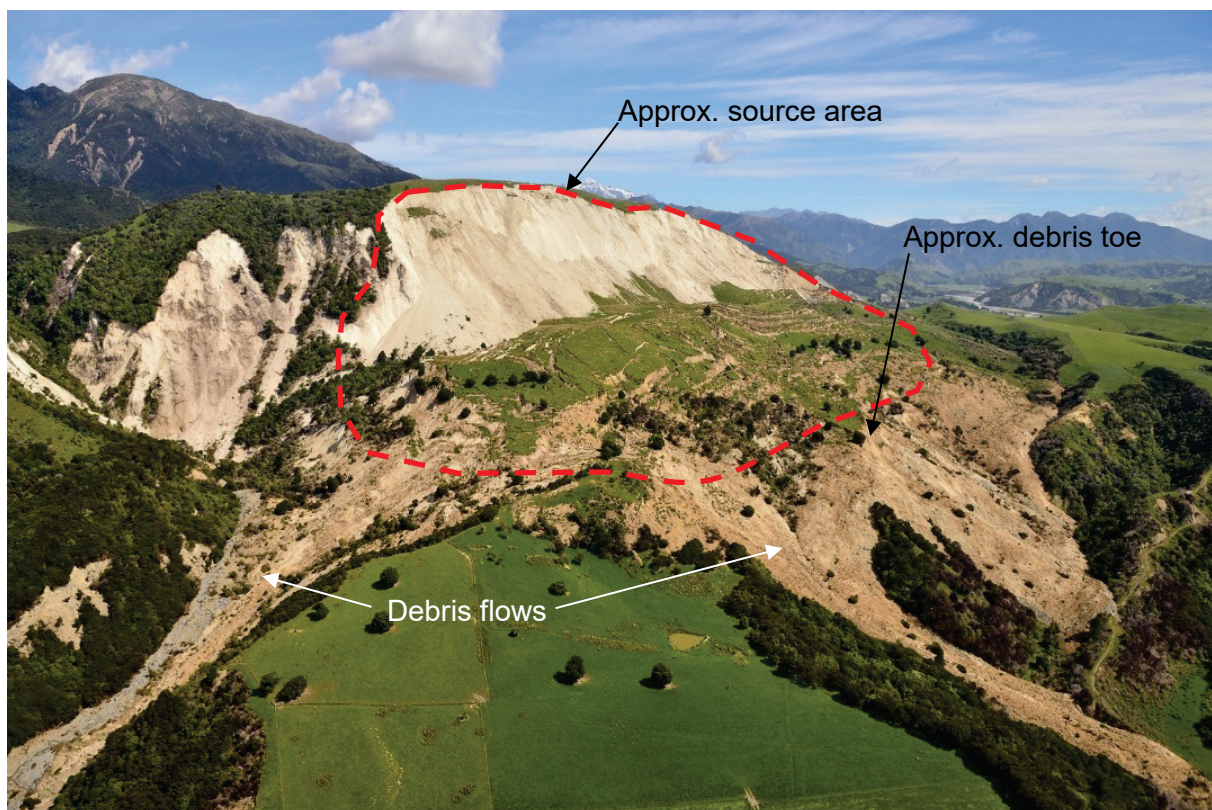
**Figure 2.5** The Seafront rock slide/slump. The landslide source area outline is shown as a red dashed line. Note the debris flows sourcing from the toe of the debris. Photo taken December 2016.

The Seafront rock slide/slump in Paleogene limestone (Figure 2.5) is the largest mapped landslide in these materials with an approximate volume of  $10 (\pm 2) \text{ M m}^3$ . The slide surface is assumed to be deep seated ( $>100 \text{ m}$  below the surface in places), with the field observations and cross sections suggesting a semi-rotational failure through the rock mass. Much of the debris has remained intact, and so the slide/slump would be classified as coherent (Keefer, 2013). The displaced mass is still creeping and several debris flows have occurred both off the toe of the intact displaced debris and the head scarp. The Papatea fault (Hamling et al., 2017; Litchfield et al., 2018; Langridge et al., 2018) ruptured through the source area suggesting that surface rupture of this fault caused the landslide to initiate (Figure 2.6). We are not sure whether the landslide initiated either from permanent earthquake-induced displacement of the ground or dynamic displacement caused by shaking, or some combination of both. The ground-surface change model (difference model) (Figure 2.6), indicates that much of the landslide debris remained intact and within the source area, and the displacement vectors of the debris indicate a rotational movement mechanism.

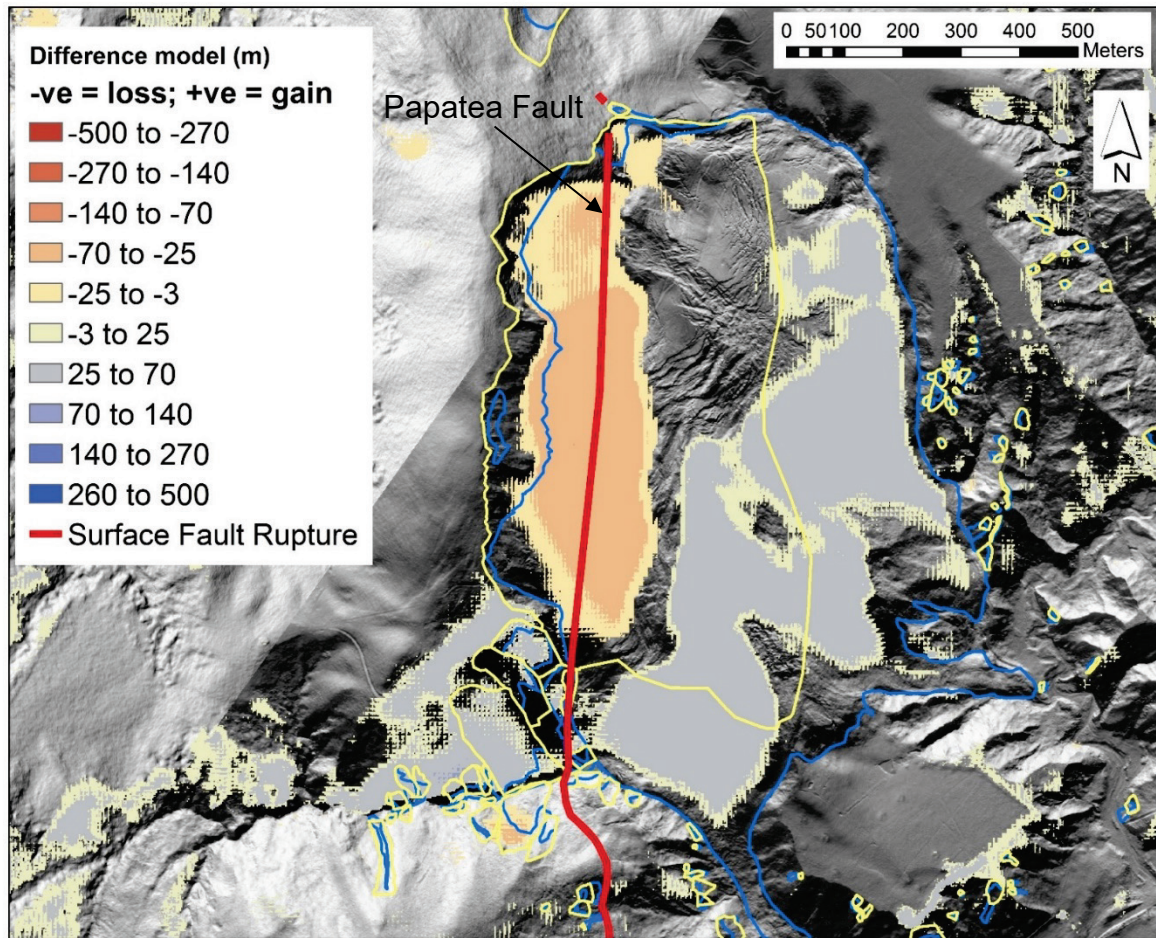
**Figure 2.6** Difference (ground-surface change) model for the Seafront rock slide/slump. The difference model was developed by subtracting the pre-earthquake digital surface model (DSM) developed from the 0.3 m resolution aerial images, from the post-earthquake surface model derived from airborne lidar. The difference model shown does not show any vertical (positive or negative) changes of less than  $\pm 3$  m. Reds, oranges and yellows represent loss of material inferred to be erosion. Blues to purples represent a gain of material inferred to be deposition.

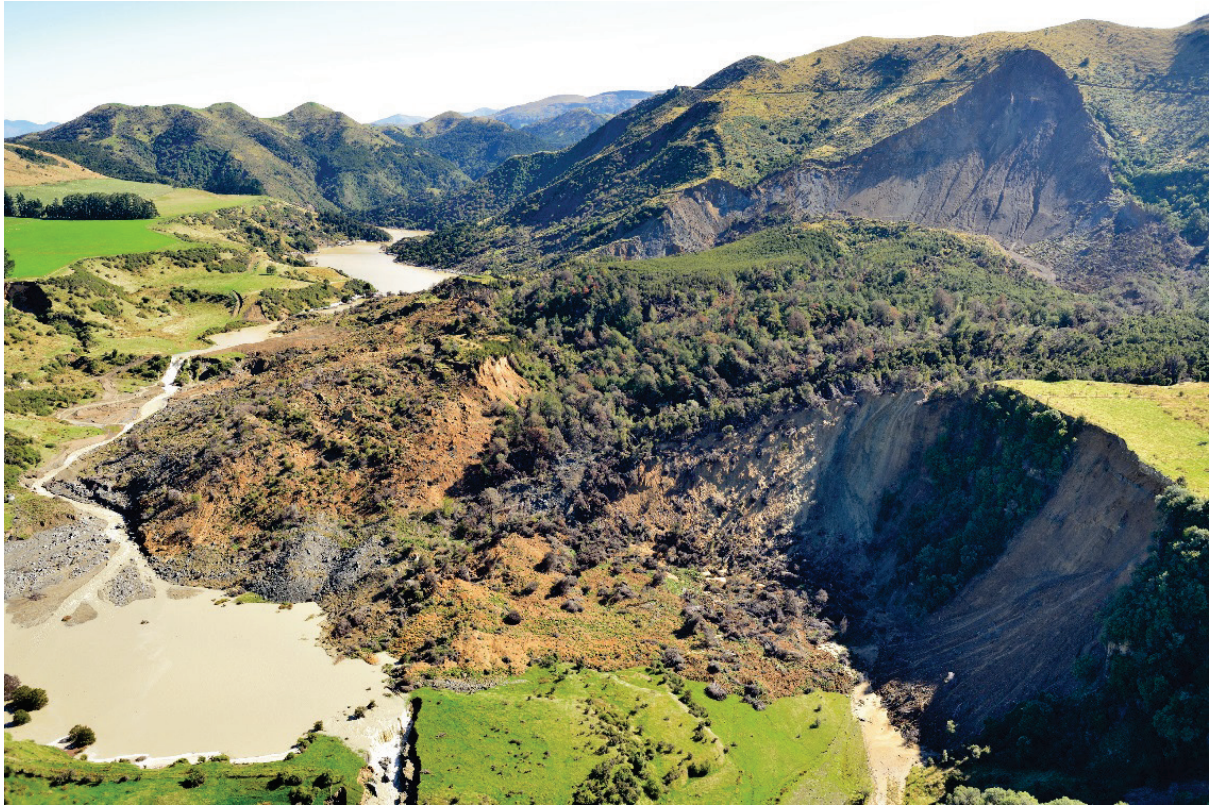
**Figure 2.7** The Leader rock slide/slump. Note the main landslide dam (upper left) has breached and flow of water (the Leader River) has re-established. Photo taken in April 2017.

The Leader River rock slide/slump in Neogene mudstone (Figure 2.7) is the largest mapped landslide in these materials with an approximate volume of  $6 (\pm 1) \text{ M m}^3$ . The slide surface is assumed to be deep seated (about 80 m below the surface in places) with the difference model (Figure 2.8) indicating that much of the debris moved as intact blocks. The displacement vectors of the debris suggest a translational failure (with some rotation at the head scarp), possibly along bedding. A faulted contact between the Lower Cretaceous greywacke and Neogene mudstone is exposed in the northern end of the landslide head scarp. Although there is no field-evidence to suggest this fault ruptured (Nicol et al., 2018), it is possible that some fault ruptured through the source area (head scarp) of this landslide. More investigation is needed to determine whether this is the case or not.

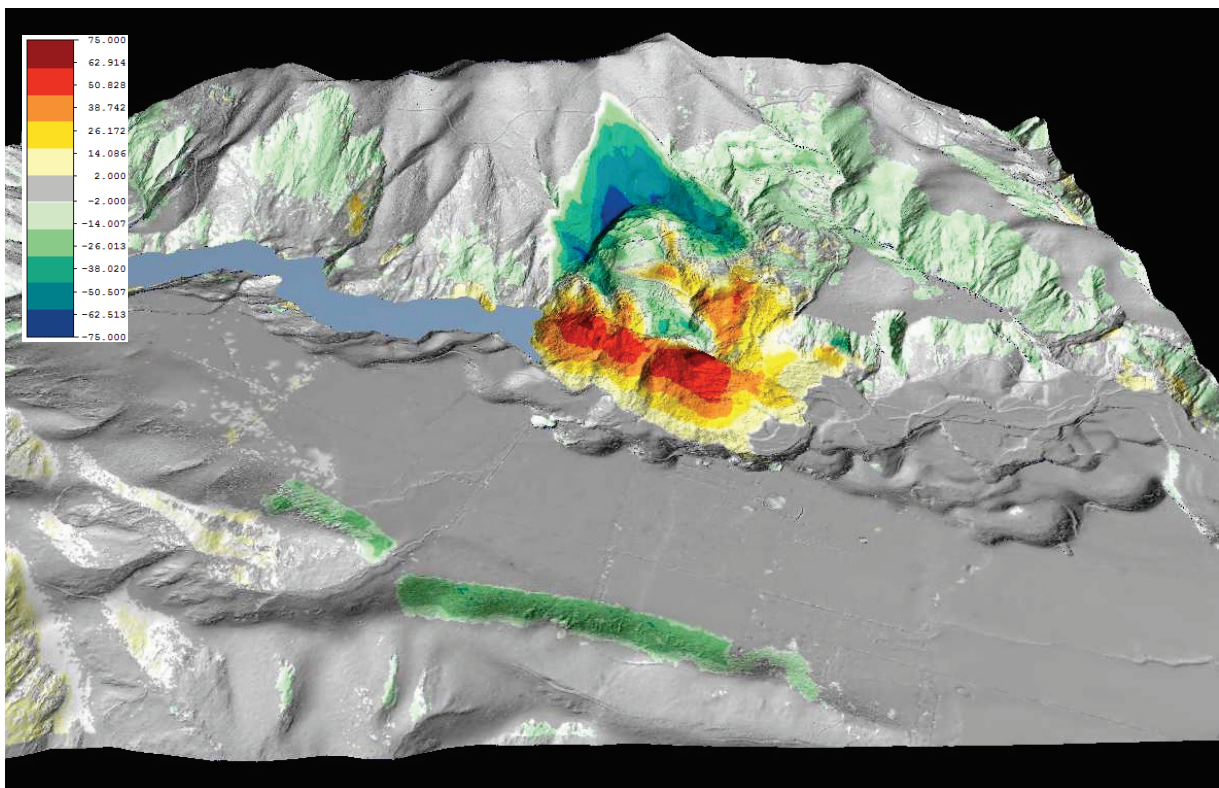
**Figure 2.8** Difference (ground-surface change) model for the Leader rock slide/slump, draped over a three-dimensional topographic model. The difference model was developed by subtracting the pre-earthquake digital surface model (DSM) developed from the 0.3 m resolution aerial images, from the post-earthquake surface model derived from airborne lidar. The difference model does not show any vertical (positive or negative) changes of less than  $\pm 2$  m. Blues to greens represent loss of material inferred to be erosion. Reds, oranges and yellows represent a gain of material inferred to be deposition.

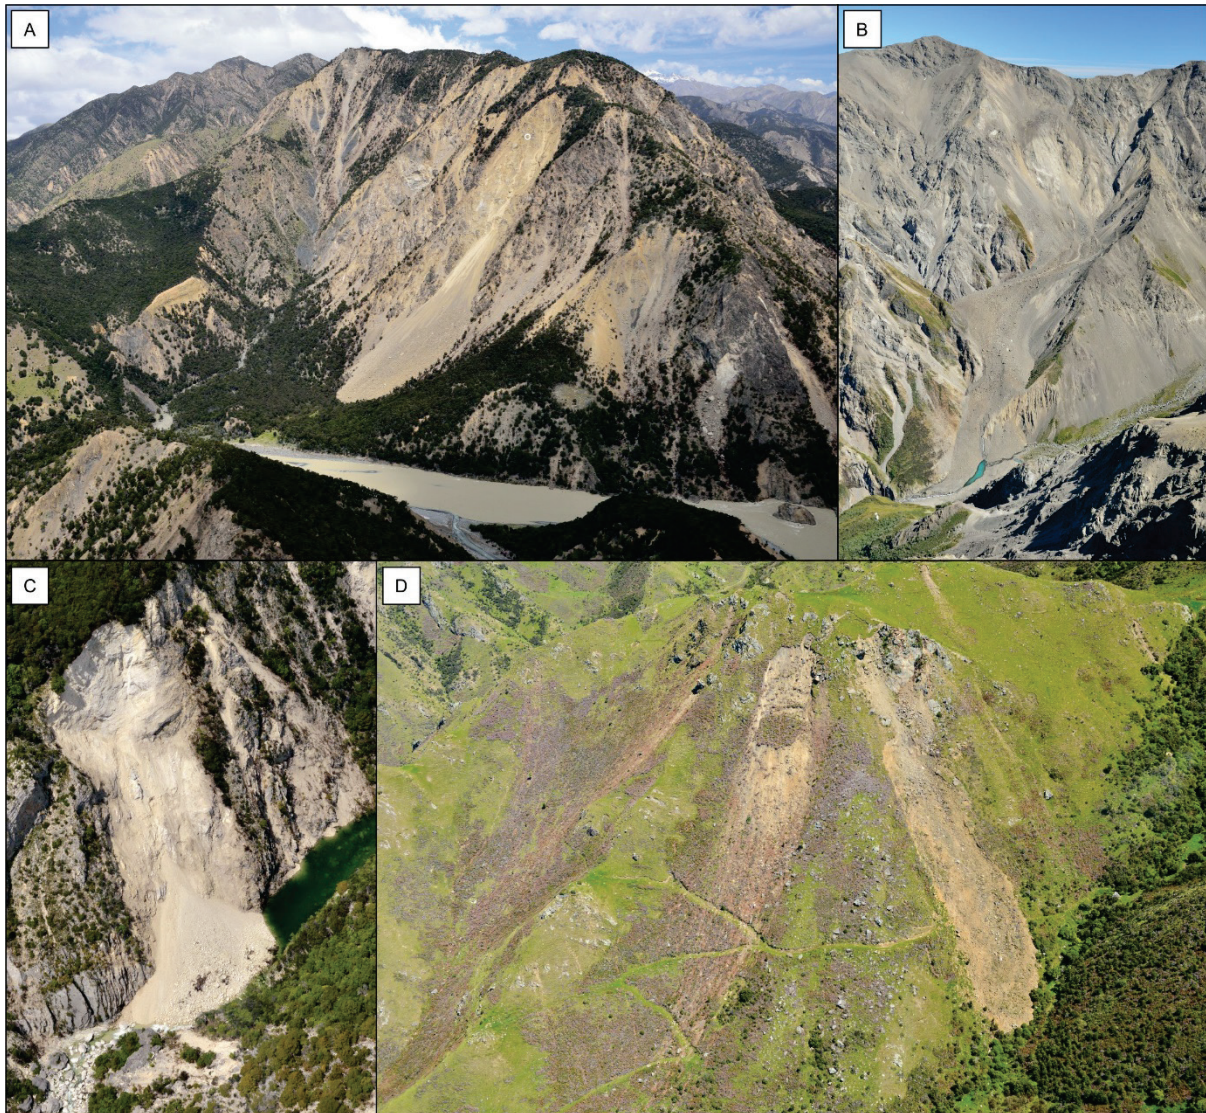
**Figure 2.9** Typical debris avalanches triggered by the earthquake on the slopes on the Inland and Seaward Kaikoura Ranges. A: Clarence valley; B Kowhai headwaters; C: Waima River; D: Flaxbourne hills.

Many smaller landslides were also triggered across an area of about 10,000 km<sup>2</sup>, with most being concentrated within an area of about 3,600 m<sup>2</sup> (Figure 2.1). Many comprised debris avalanches, the most notable being those along the coast north and south of Kaikoura (Figure 2.9). The landslides along the coast caused substantial damage to both State Highway (SH) 1 and the northern section of the South Island Main Trunk Railway (Figure 2.10), blocking both in multiple locations (Davies, 2017). It took more than a year to reopen both the road and rail after the earthquake, in part because of the challenges of removing the landslide debris.

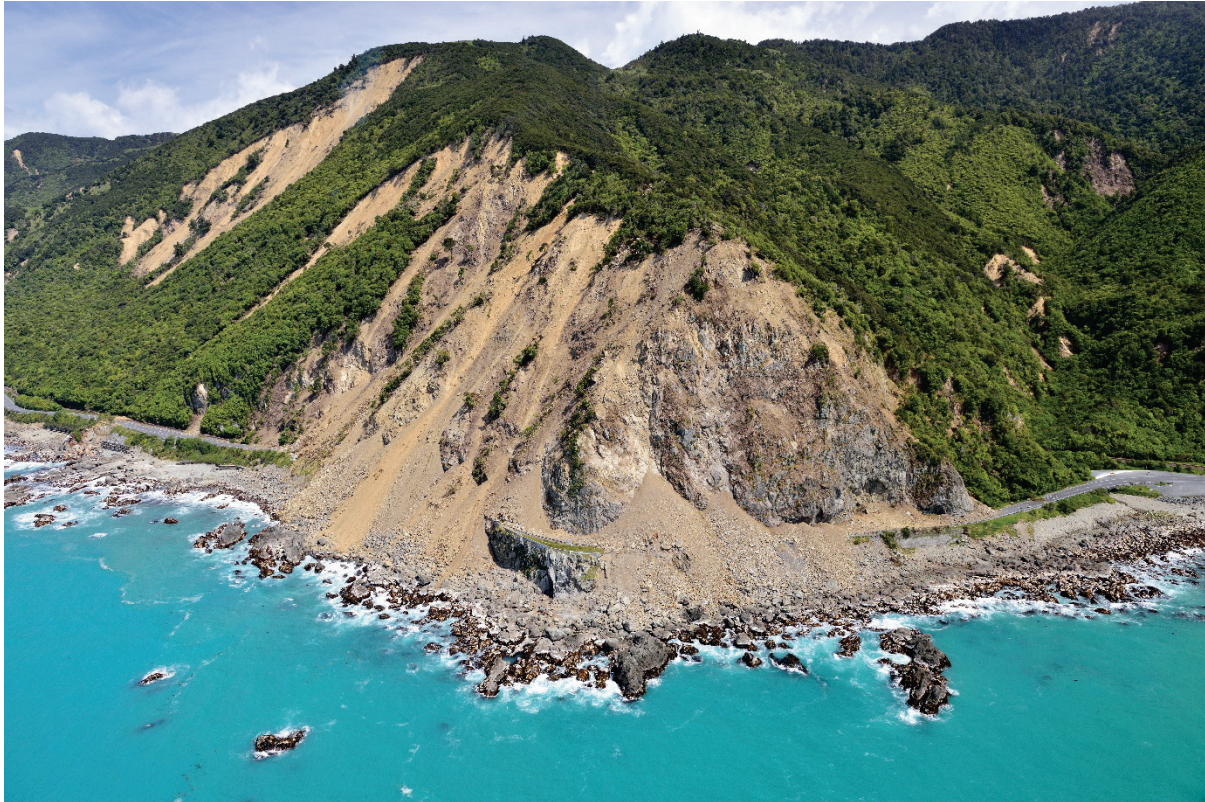
**Figure 2.10** One of the many large-scale failures of coastal cliffs (Ohau Point, north of Kaikoura township), which inundated State Highway 1. At this location, the South Island Main Trunk Railway is within a tunnel through the headland.

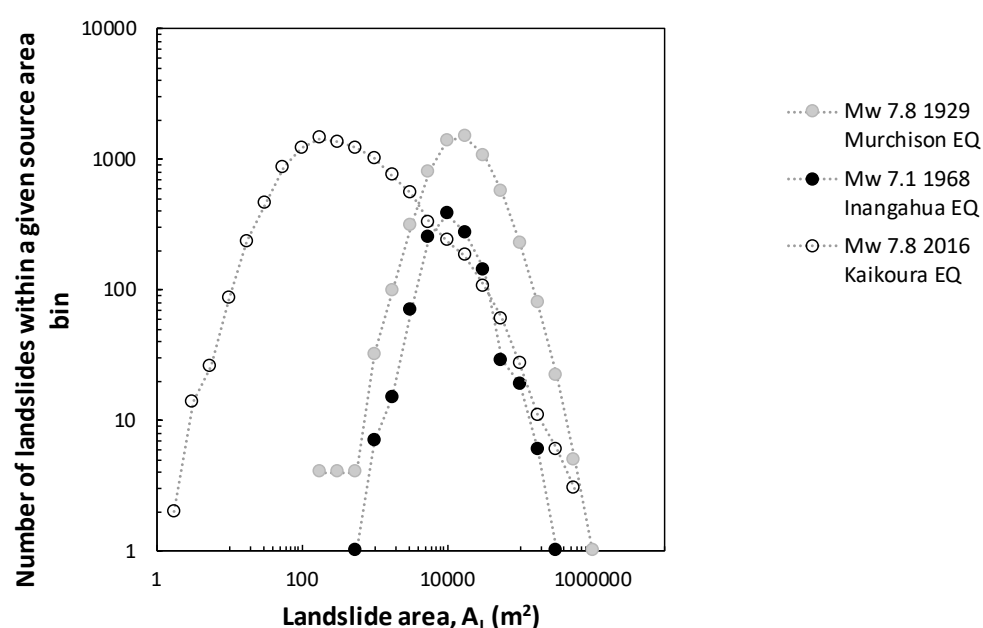
**Figure 2.11** Landslide source area distribution for landslides triggered by the Kaikoura Earthquake and other significant earthquakes in New Zealand. The number of landslides (frequency) with source areas within each source area bin. The figure plots landslides generated by the Kaikoura Earthquake, the M<sub>w</sub> 7.1 1968 Inangahua, New Zealand earthquake (Hancox et al., 2014) and the M<sub>w</sub> 7.8 1929 Murchison, New Zealand earthquake (Hancox et al., 2016).

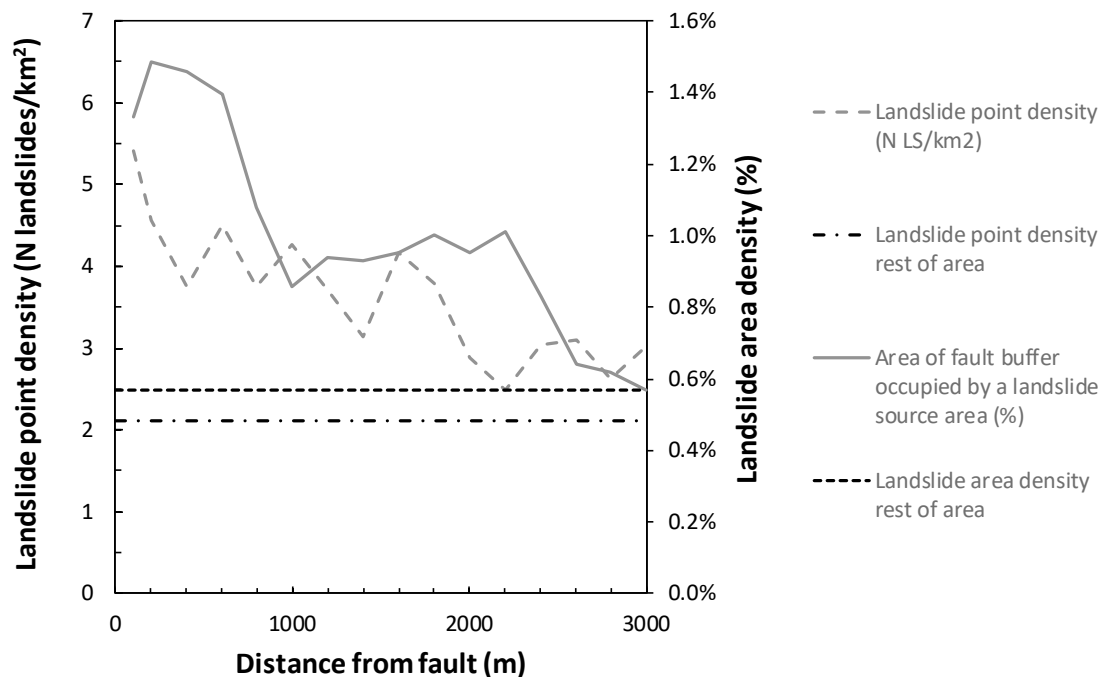
**Figure 2.12** Landslide point and area density (N=10,195 landslides) within each 200 m distance from fault buffer. Landslide density is calculated by taking the centroid of each landslide source area that falls within each 200 m distance buffer from the mapped surface expression of the faults that ruptured during the earthquake. The number (N) of landslide points within each distance from fault bin range is then divided by the area of slope (km<sup>2</sup>) within each bin. The landslide area density is also shown, which is calculated in the same way as the landslide point density; however, the area of each landslide source (km<sup>2</sup>) within each distance from fault bin is summed and divided by the total area of ground within each 200 m bin.

3. the landslide density within  $2,500 \text{ m}$  of a mapped surface fault rupture is as much as three times higher than those densities farther than  $2,500 \text{ m}$  from a ruptured fault;

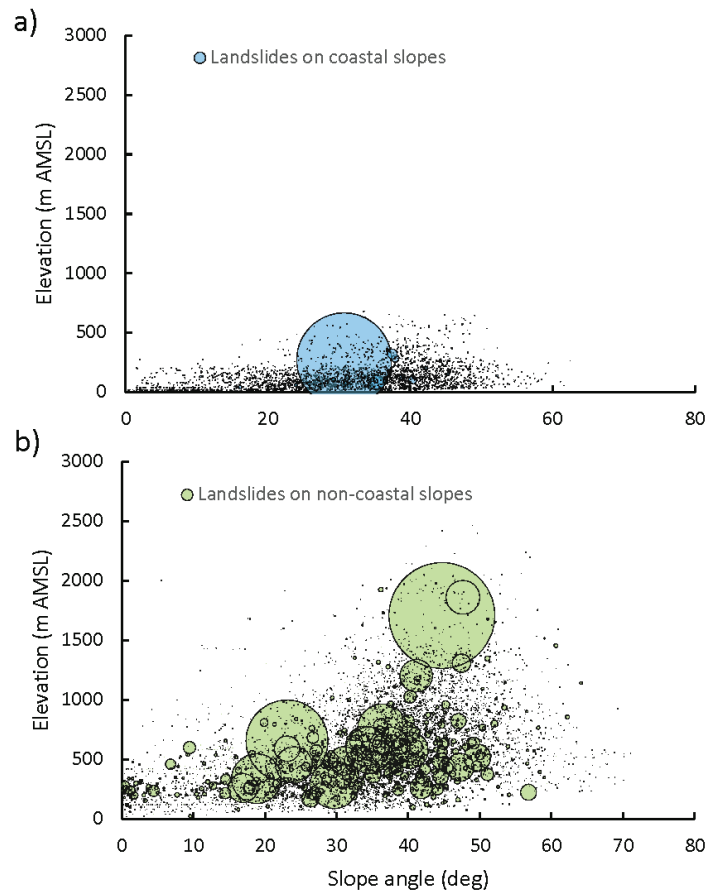
**Figure 2.13** Landslide source areas (N=10,195 landslides) normalised relative to the largest mapped landslide (area in km<sup>2</sup>) and their associated elevation and slope angle taken from the 8 m resolution New Zealand digital elevation model.

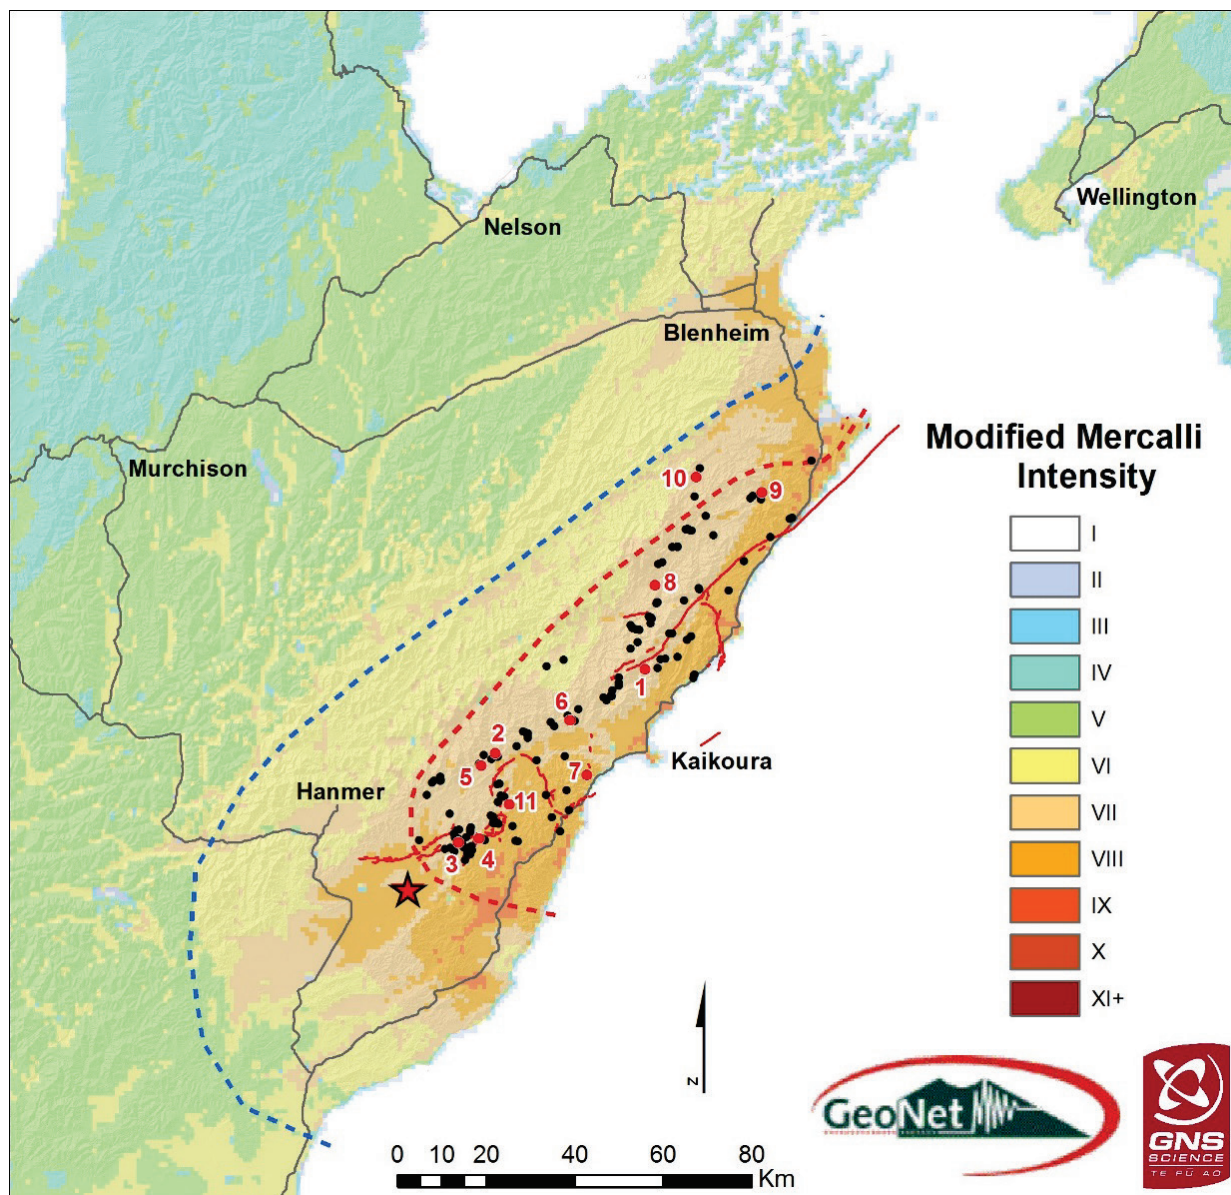
**Figure 2.14** The landslide dams triggered by the  $M_w$  7.8 14 November 2016 Kaikoura Earthquake. The epicentre is shown by the red star. The colours depict the MM (ground) Shaking Intensity, with MM VIII in the worst affected areas and isolated pockets of MM IX where deep soils are present. Areas of light to moderate landslide damage (area between the blue dashed and red dashed lines), and severe landslide damage (area inside the red dashed line) are also shown. Faults that ruptured to the ground surface are shown as solid red lines (Litchfield et al., 2018). The landslide dams are shown as black dots, or for the dams assessed having the highest failure hazard and consequential risks are numbered and shown by a red dot: 1: Hapuku; 2: Conway; 3: Stanton; 4: Leader; 5: Towy; 6: Linton; 7: Ote Makura (Goose Bay); 8: Clarence; 9: Waima/Ure; 10: Medway; 11: Gelt. (Map updated from Dellow et al., 2017b).

Aerial (helicopter) reconnaissance flights, carried out in the first few days and weeks after the earthquake eventually identified 196 significant drainage blocking or drainage constricting landslides in the area affected by landslides (Figure 2.14) (Dellow et al., 2017b). Of concern was the debris flood and flow hazards that could result should some of the landslide dams breach catastrophically. Several of the dams were located upstream from people and critical infrastructure, such as road and rail bridges, which could potentially be at risk if a dam-breach and flood event were to occur.

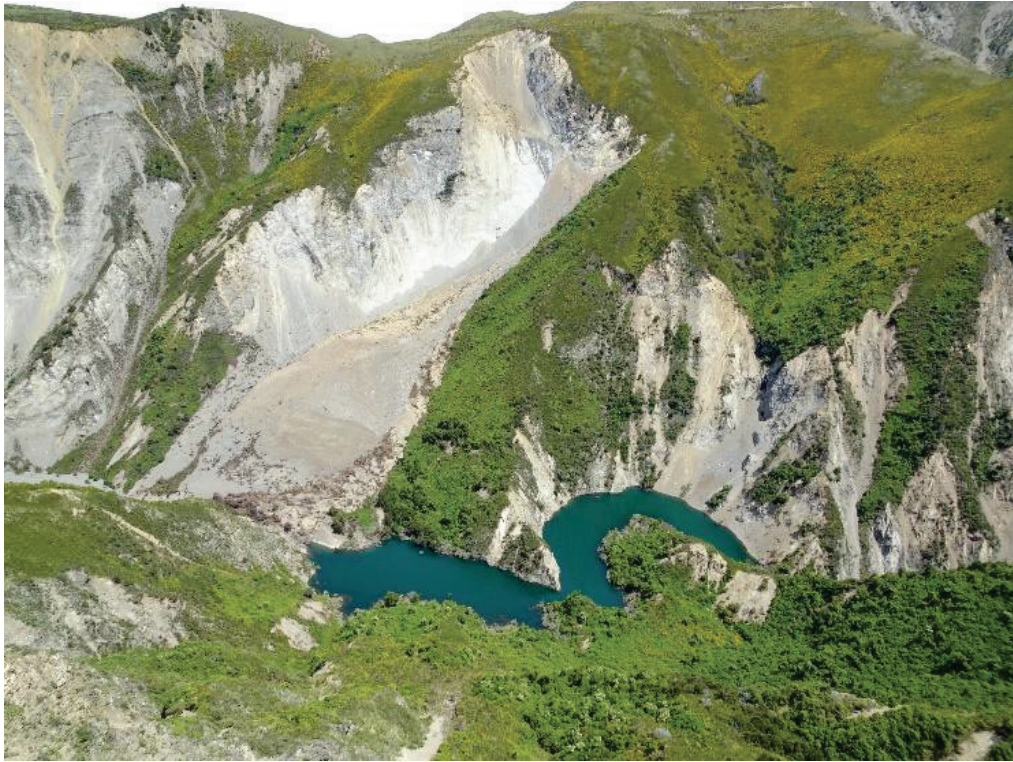
**Figure 2.15** Landslide dam on the Conway River in greywacke. Photograph taken December 2016.

Each landslide dam and impounded lake varied in geometry and volume. Figure 2.15 to Figure 2.17 show examples of the dams generated in different source materials. Some dams, such as the main one on the Clarence River, breached within 24-hours of being formed, but most breached during rainstorms in March, April and October 2017. The only significant dam that remains is the one on the Hapuku River (Figure 2.16). This dam has partially failed via a combination of backward erosion on the downstream face and overtopping. Site-specific surveys pre- and post-breaching were carried out for the main landslide dams on the Hapuku, Linton, Conway, Towy, Stanton and Leader rivers and the Ote Makura Stream, where people and infrastructure were potentially at risk. These are discussed in the next section.

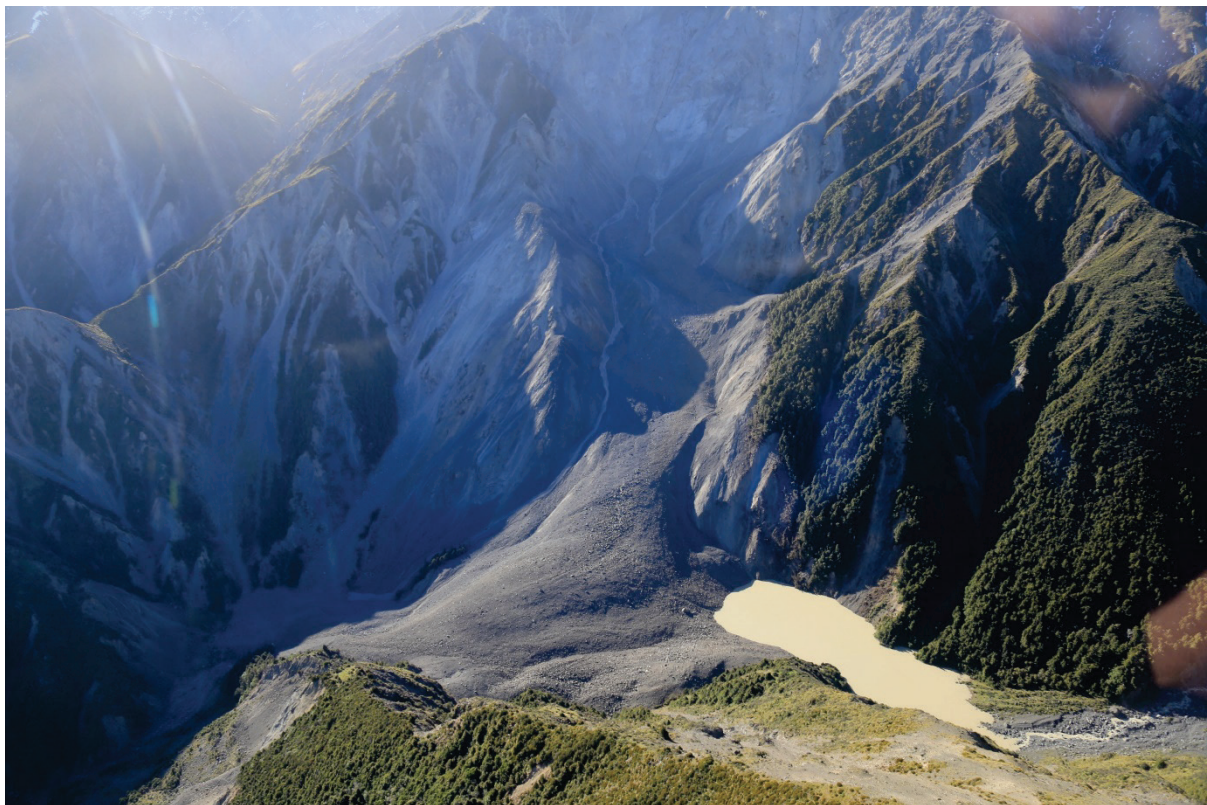
**Figure 2.16** Landslide dam on the Hapuku River in greywacke. Photo taken December 2016.

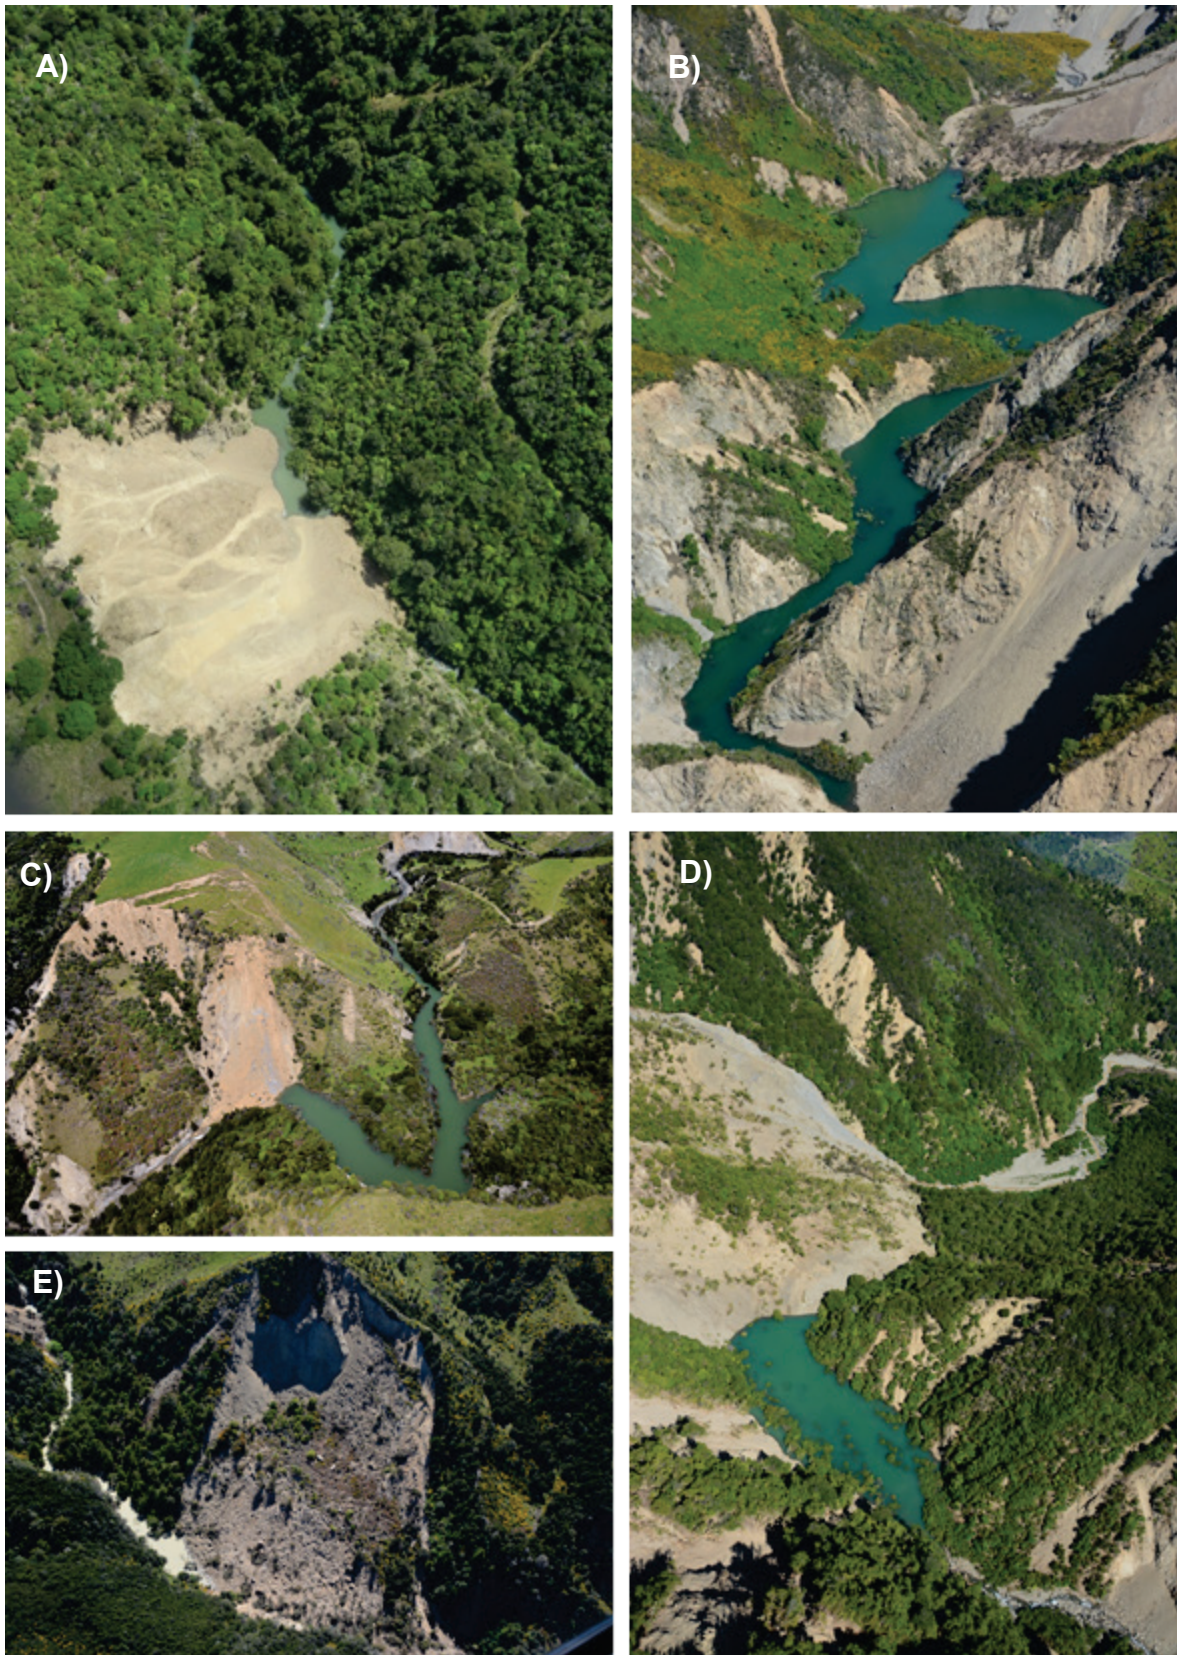
**Figure 2.17** A) Landslide dam on Ote Makura Stream (upstream from Goose Bay) in greywacke. B) Another view of the dam on the Conway River in greywacke. C) Landslide dam on the Medway River in sandstone and siltstone. D) Landslide dam on the Linton River in greywacke. E) Landslide dam on the Gelt River in greywacke. All photos taken in December 2016.
