## **Kaikoura Earthquake Short-Term Project**

**Title: Landslide inventory and landslide dam assessments**

**Kaikoura Earthquake Short-Term Project: Landslide  
inventory and landslide dam assessments**

**GNS Science Report 2018/19**  
**June 2018**

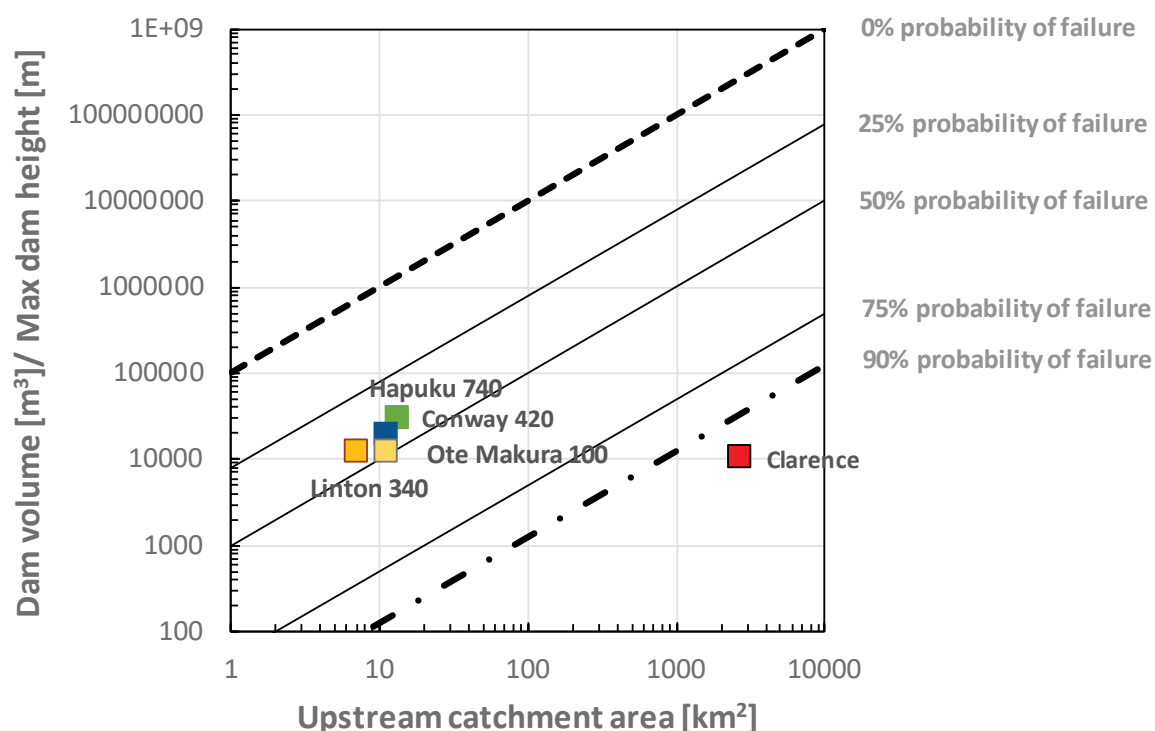
**Figure 2.18** Landslide dam probability calculated from the data presented by Tacconi et al. (2016) and Korup (2004). The dam volumes and maximum (Max) dam heights and the upstream catchment areas calculated for the main landslide dams triggered by the Kaikoura Earthquake are plotted so that their probability of failure can be evaluated.

The methodology used to assess the likelihood of dam failure, adopting empirically-based models is detailed in Appendix 4. The key findings from this work are shown in Figure 2.18. The plot suggests that the main dam on the Clarence River was calculated to have a high probability of failure. This dam failed within 24-hours of being formed. Conversely, these data indicate that the dam on the Hapuku River has the lowest calculated probability of failure of the Kaikoura landslide dams plotted. These dams have now failed, most failed in the rain that occurred during Cyclones Cook and Debbie in March and April 2017, but the Hapuku dam is still present and poses a potential, albeit reduced risk, to people downstream.

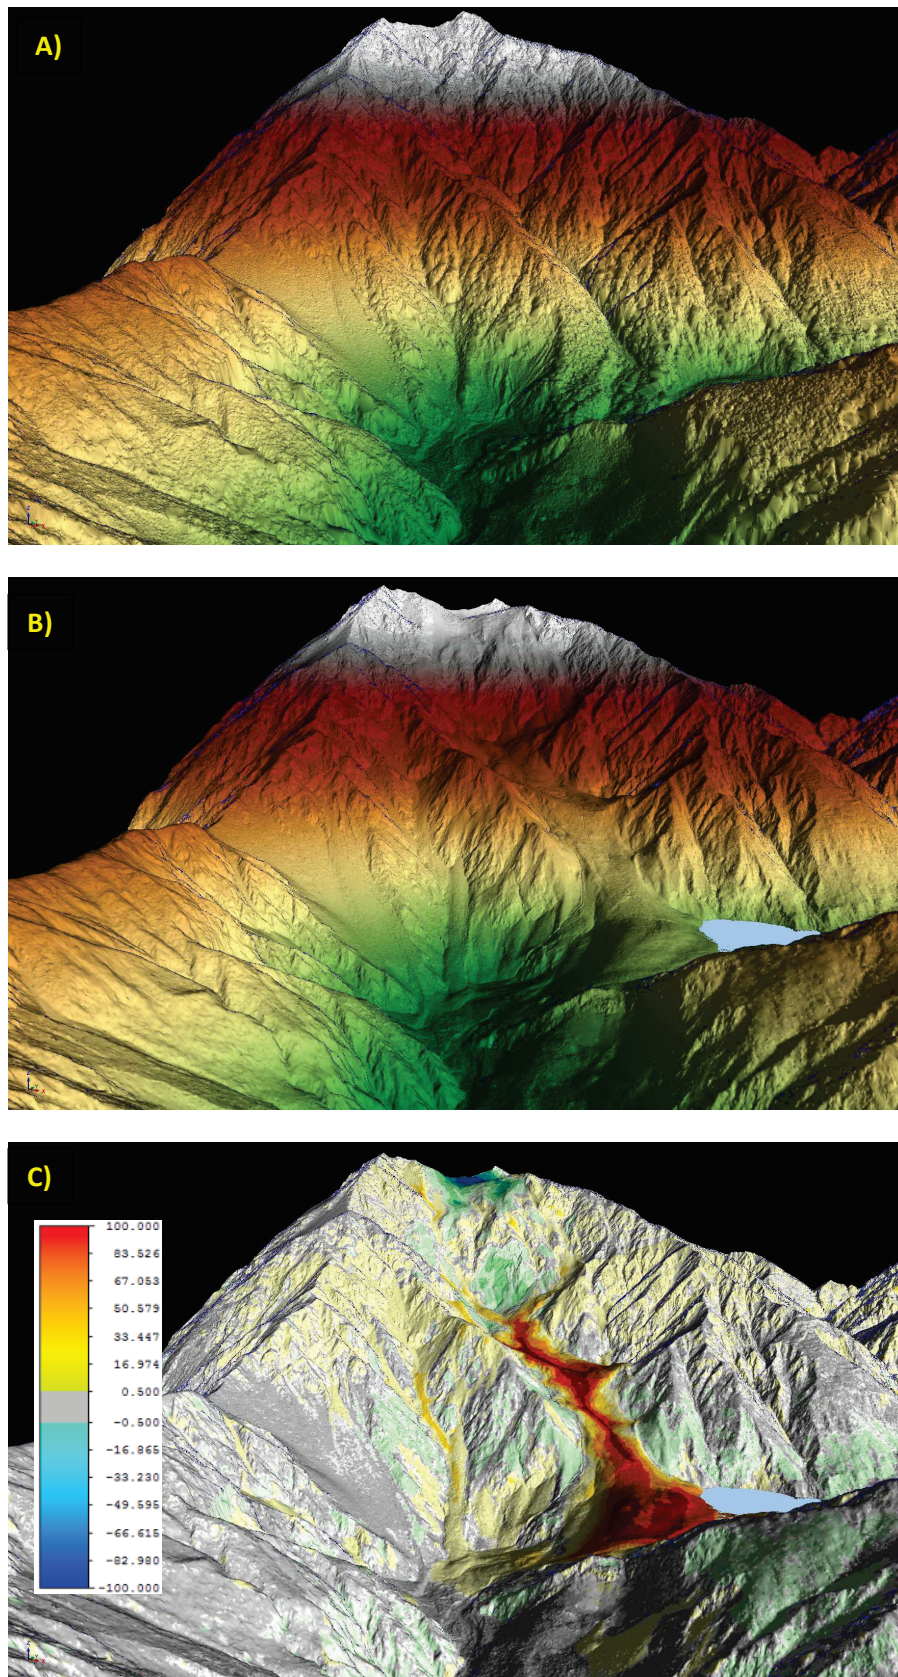
**Figure 2.19** Hapuku River landslide and dam site-specific assessment results: A) pre-earthquake digital surface model of slopes derived from photogrammetry. B) Post-earthquake digital elevation model derived from airborne lidar. C) the difference between the two surface models, where warm colours are deposition of debris, and the cold colours are loss of material in the landslide source area. The lake impounded behind the dam is shown in light blue.

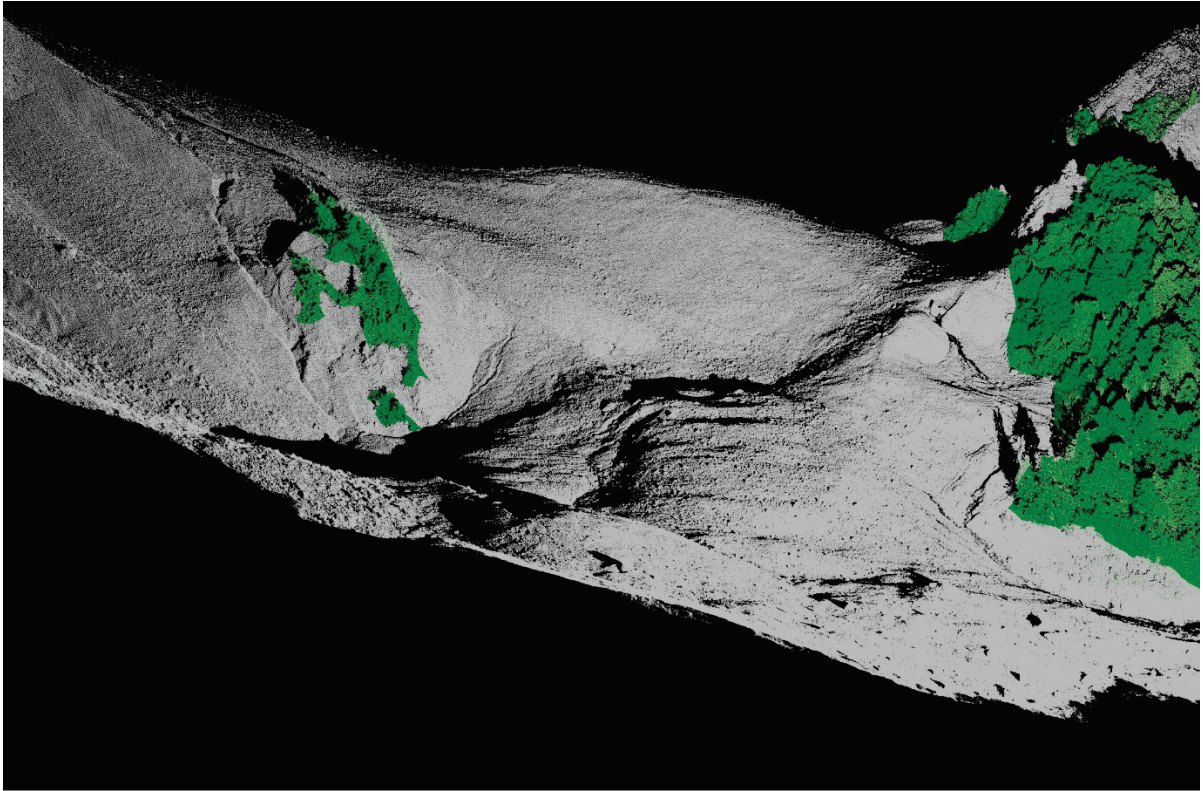
**Figure 2.20** Point cloud from the ground based terrestrial laser scan (TLS) surveys of the Hapuku dam, looking upstream, vegetation is shown as green. Survey carried out in December 2016.

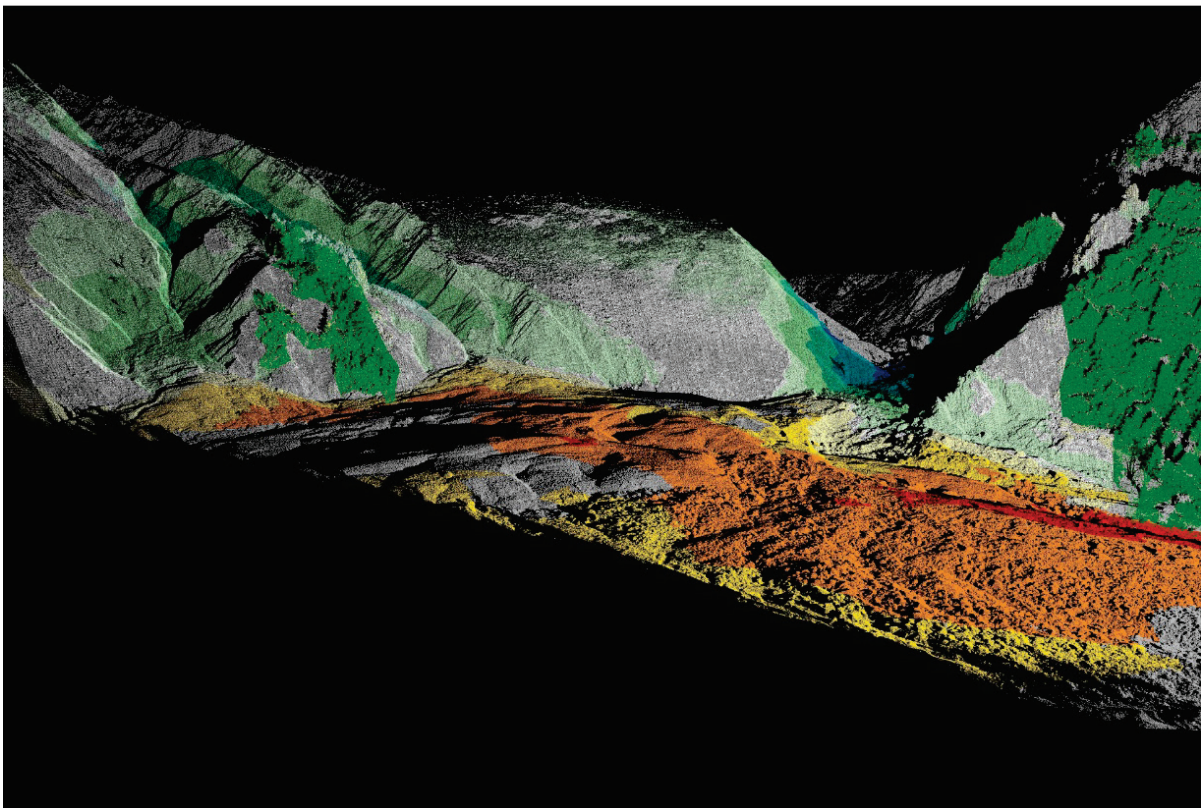
**Figure 2.21** Coloured point cloud from the ground based terrestrial laser scan surveys of the Hapuku River dam, looking upstream from October 2017, after it had overtopped and breached. Note the breach geometry on the right of the lower image. The approximate volume of dam material eroded is about 1 M m<sup>3</sup>. Much of the dam is still present, but water continues to flow out of the lake along the breach channel. The orange and red colours represent material deposition (aggradation) and the blues and greens represent material erosion.

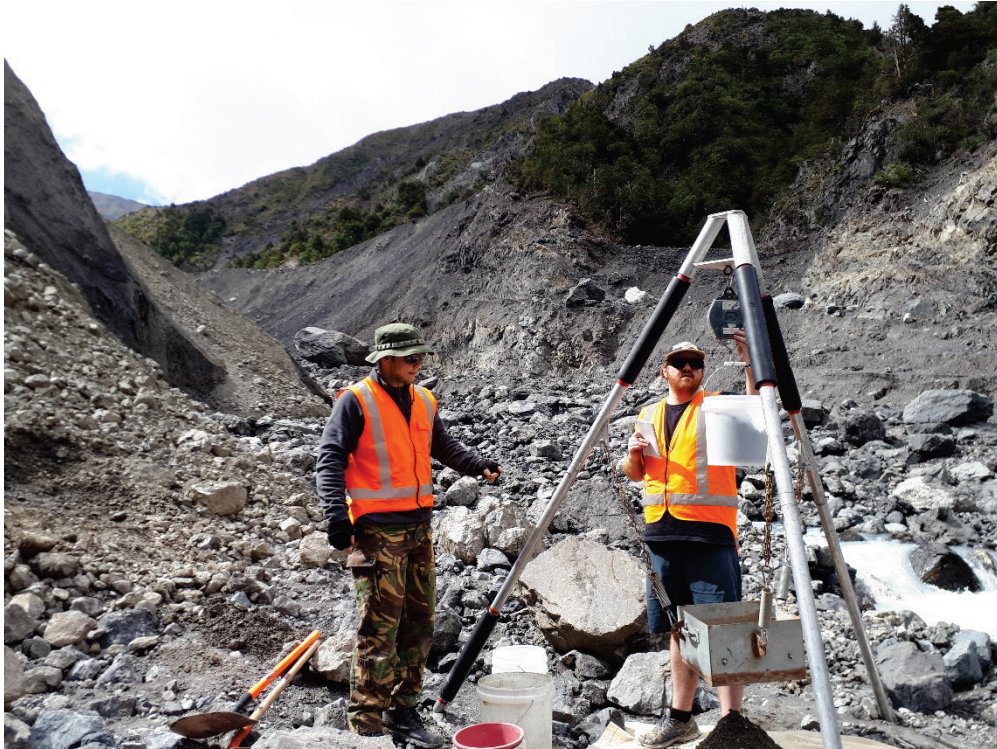
**Figure 2.22** University of Auckland students sieving landslide debris from the Hapuku River landslide dam after it breached in October 2017.

3. Field surveys of debris flows and floods and the particle size distribution (Figure 2.22) of the debris, generated by the breaches of the dams were used to calibrate the dam-breach debris-flood inundation forecast simulations (carried out before the dams breached) (Figure 2.23). These comparisons showed that many of the downstream consequences (in this case the debris inundation levels) were similar to the debris inundation levels, forecast by the simulations assuming the “most likely” conditions (Dellow et al., 2017). Therefore, the forecast models matched well what happened, and so are a useful method for assessing debris flood hazards in similar future events.

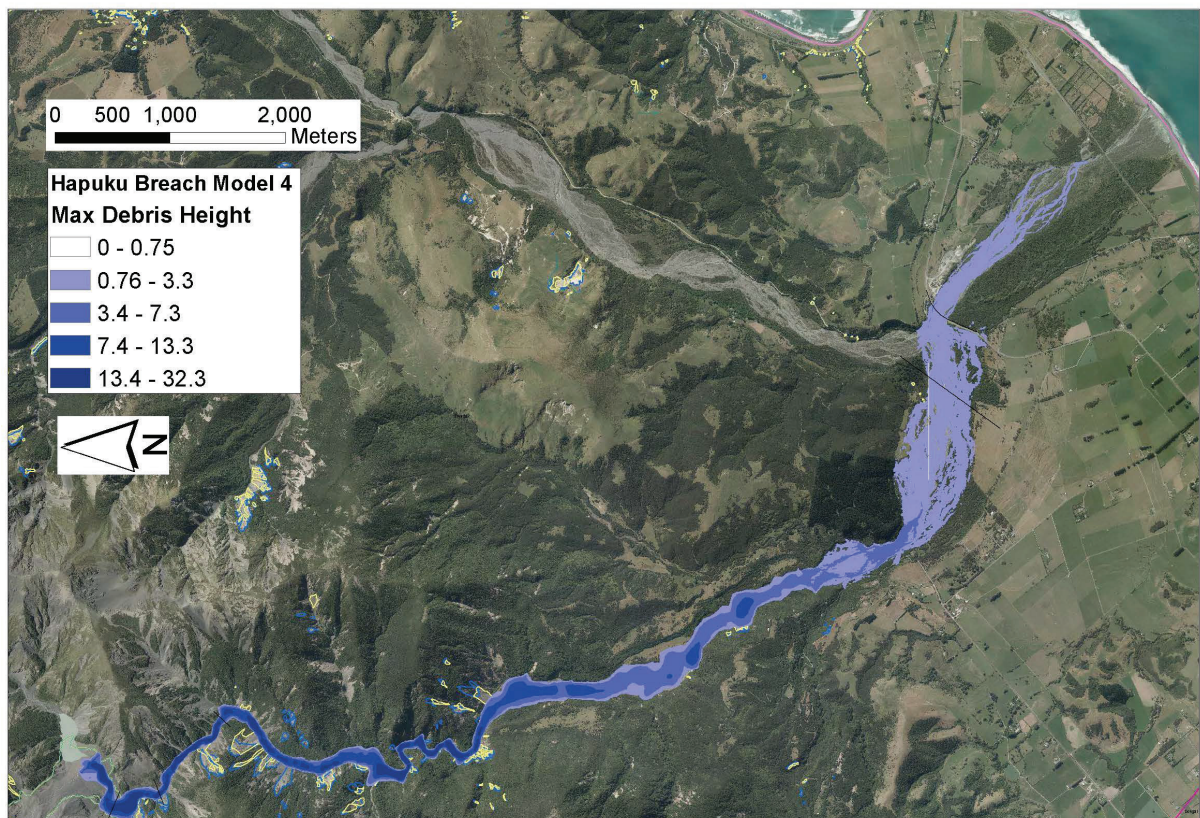
**Figure 2.23** Landslide dam-breach debris flow/flood simulation for the Hapuku River landslide dam derived from numerical modelling. The model simulates the assumed “worst credible” event, based on the entire dam failing catastrophically. In October 2017, the dam overtopped and partially breached. Much of the material forming the dam remains, but the impounded lake level has dropped as a result erosion caused by water flowing through the breach channel.

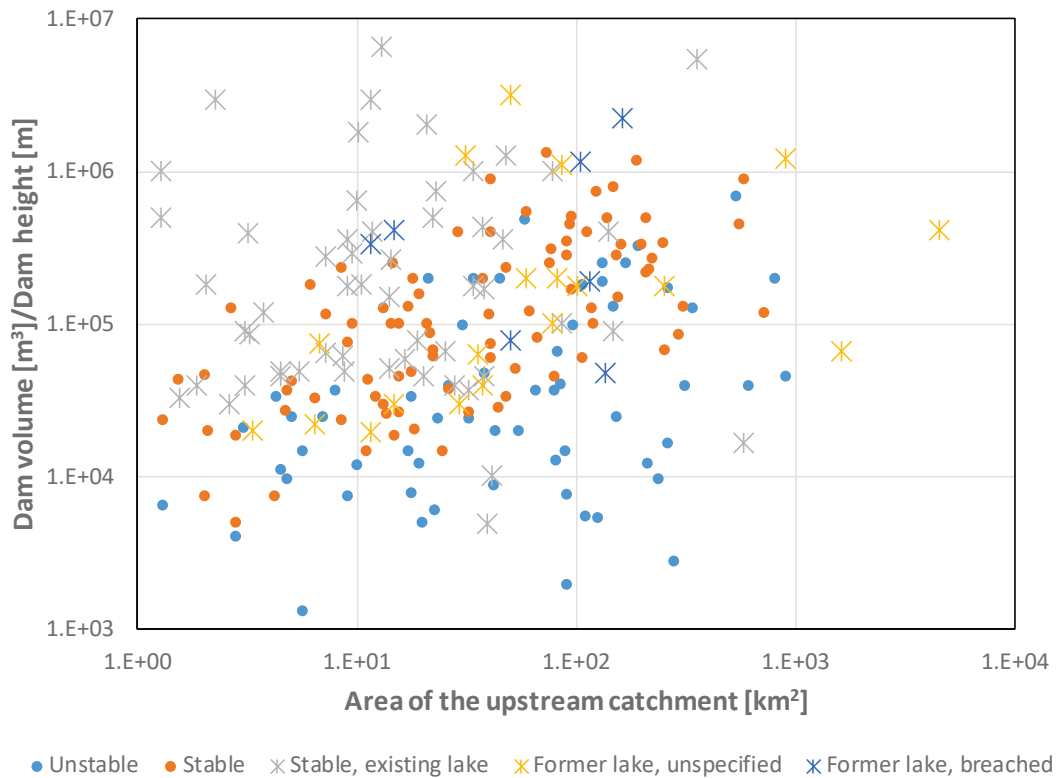
**Figure A4.1** Landslide dam volume divided by dam height plotted against the area of the upstream catchment for each landslide dam included in the Korup (2004) and Tacconi et al. (2016) datasets. The red and blue dots represent the Italian dam dataset presented by Tacconi et al. (2016) and crosses represent the New Zealand dataset from Korup (2004). The Italian dataset comprise 152 data points and the New Zealand dataset comprises 85 data points. Total N=238.

The Tacconi et al. (2016) and Korup (2004) datasets were digitised (Figure A4.1), and the probability of failure (breaching) for dams with different values of DBI calculated (Figure A4.1). The dam volumes, dam heights and upstream catchment areas for the landslide dams triggered by the Kaikoura Earthquake and which posed a potential risk to life were calculated and plotted on Figure A4.1.
