VOLCANIC ASHFALL

ADVICE FOR ROAD NETWORK OPERATORS

Ash Impacts On Road Networks

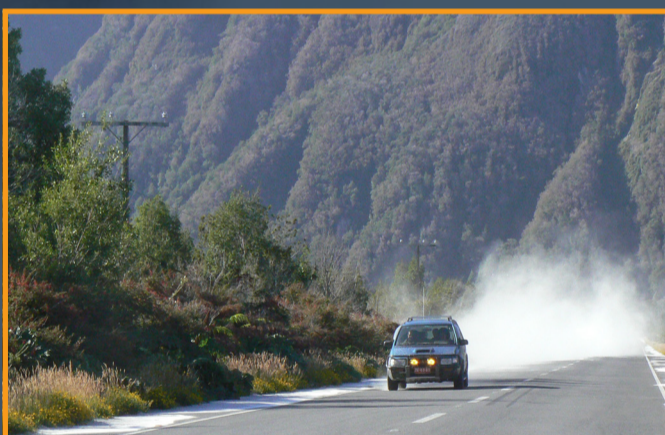
Volcanic ash lifted by vehicle near Chaitén volcano, Chile

- Impacts can continue after eruptive activity has ended due to the remobilisation of ash by wind, water, traffic and/or other human activity.
- Ash remobilised in rivers and creeks can lead to lahars (volcanic mudflows) causing damage to bridges and other infrastructure.

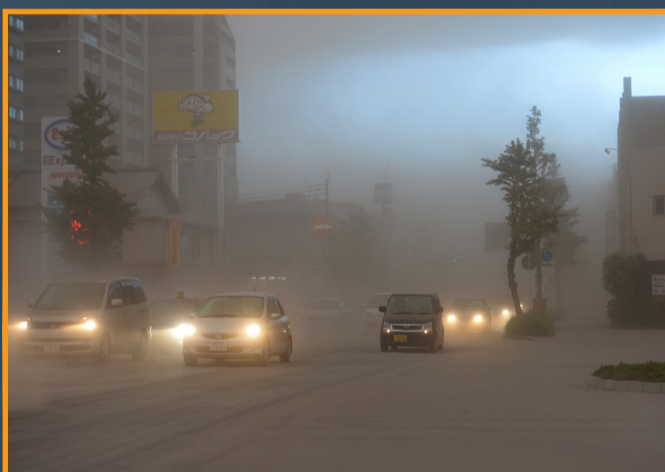
Reduced visibility and covered road markings in Kagoshima City due to ashfall from Sakurajima volcano, Japan (photo credit: Minami Nippon Shimbun, Kagoshima, Japan).

- Visibility can be severely reduced during and after an eruption due to ash suspended in the air.
- Traction on ash-covered roads is reduced in both dry and wet conditions.
- Road marking coverage can occur when ash is less than 1 mm thick.
- Accident rates will likely increase.
- Vehicle damage may consist of the clogging of filters, corrosion of metal surfaces, and abrasion damage to windscreens, paintwork and moving engine components.
- Roads may become impassable (to 2WD vehicles) when ash on the ground is around 100 mm thick.

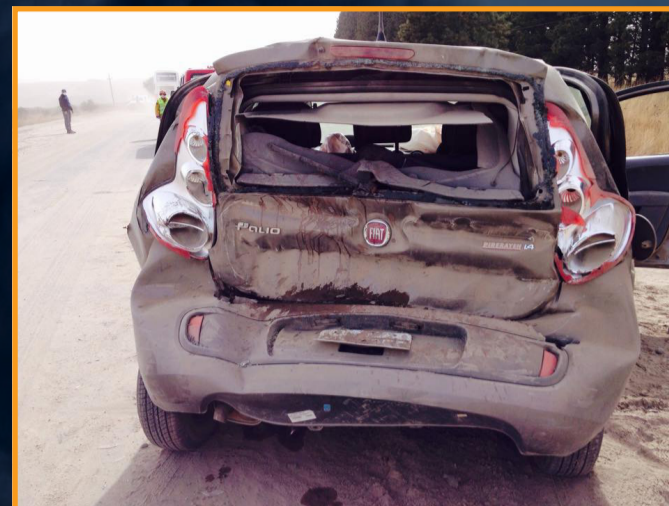
Accident damage in Junín de los Andes, Argentina following ashfall from Calbuco volcano, Chile. (photo credit: Junín de los Andes Fire Department, Argentina)

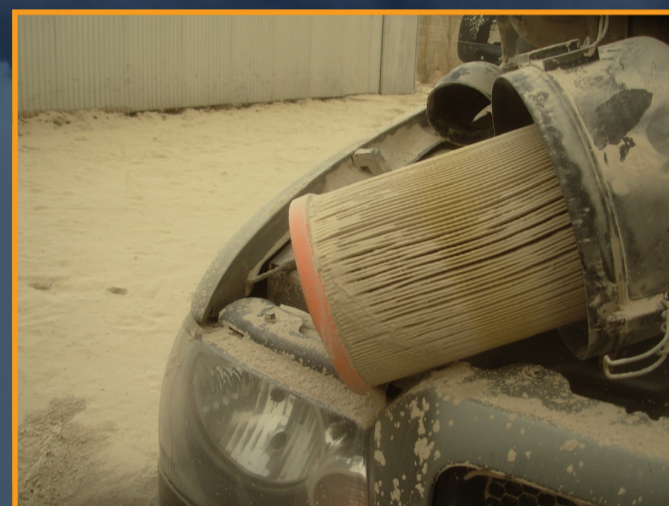
Heavy ash contamination of car air filter following 50 mm of ashfall from the 2011 eruption of Cordón Caulle volcano, Chile. (photo credit: Ailen Rodríguez, Jacobacci, Argentina)

- Avoid using wipers to clear ash from windscreens as this can cause abrasion damage. Rinse ash from windscreens and vehicle paintwork with water.
- Clean or replace air and oil filters regularly.
- Apply lubricant/grease more frequently and check for wear.
